2018 Building Condition Assessment

Minimum Modifications Required To Maintain Existing Building Performance Level

Jean Marc Lalonde Arena

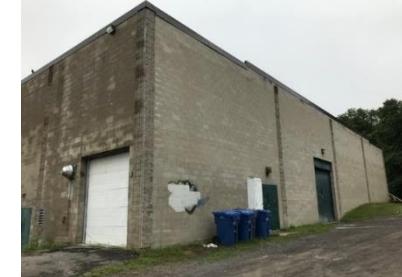
Item	Element	Condition	Comment	Remediation/Action	OPCC	Photograph
1	Foundation.	Good	Exposed portion of foundation walls appears to be in good condition with no visible signs of distress or movement.	None required.	-

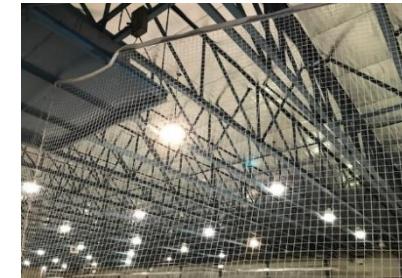
- d. Some rusting was noted on the steel columns and base plates within the westerly rooms below the sloped seating. The corrosion is likely due to a combination of systems, environmental operating conditions and infiltration of winter air at numerous vent fans producing high, humidity levels. Cleaning, preparation and painting is advised.

2	Building Frame / Steel Superstructure.	Fair	Exposed portion of the superstructure appears to be performing as intended with minor maintenance required (painting / rust removal).	Rust removal and painting.	\$10,000.00

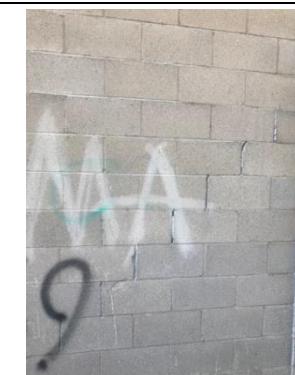
3	Infill Block Walls	Good	Given the robust nature of materials employed, the building shell is in good condition and sound and will only require regular nominal maintenance.	The seal should be repaired at the 'laddering' in the mortar of the east wall.	\$20,000.00

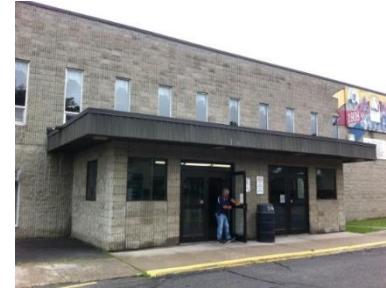
Item	Element	Condition	Comment	Remediation/Action	OPCC	Photograph
1	Cinder blocks wall (Vestibule)	Good	In good condition.	None required.	-

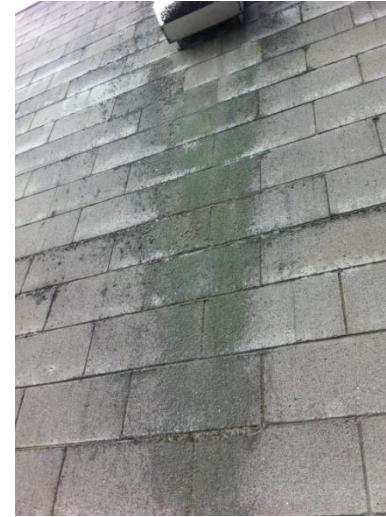
2	Exterior wall surface under one exterior light fixture. (on north facing wall)	Poor	Sign of water penetration and mold growth.	Wash and remove molded area with heavy-duty cleaner	\$800.00

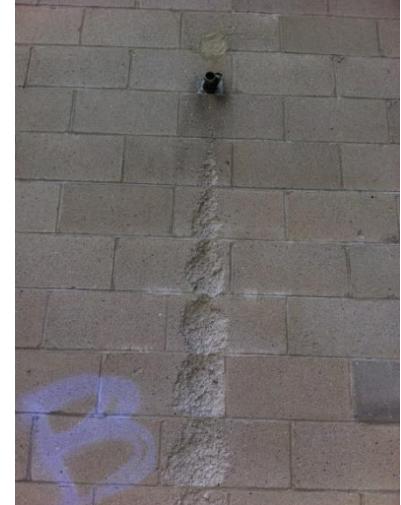
3	Exterior wall surface under drainage pipe (on north wall)	Poor	Clear sign of spalling due to freeze-thaw while saturated with water.	Clean damage surface; Apply a layer of epoxy adhesive and patch the area with concrete. Install downspouts and direct water away from building.	\$3,500.00

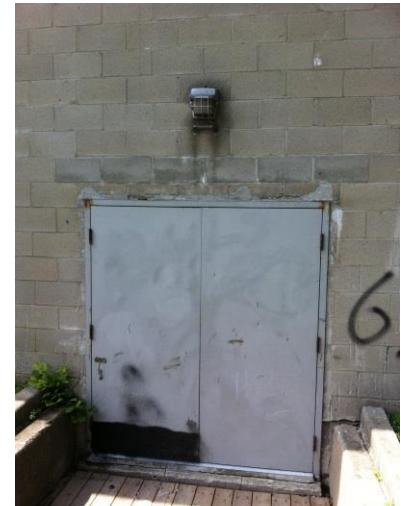
4	Exterior wall surface under lighting fixtures and around door lintel	Fair	Sign of water penetration.	Clean surface and apply sealer. Further investigation of door lintel condition is recommended.	\$1,800.00 Including investigation

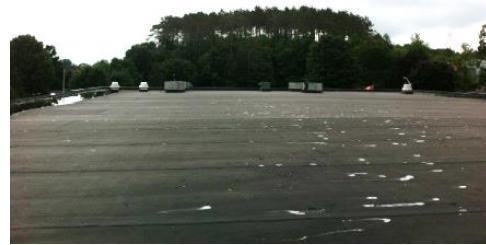
5	Roofing membrane	fair	Water leaks into the building when it rains.	Conduct roof leak investigation to locate the source. Proper repair method will be determined and undertaken depending on the finding.	\$15,000.00 (for investigation) \$80,000.00 (for repairs)

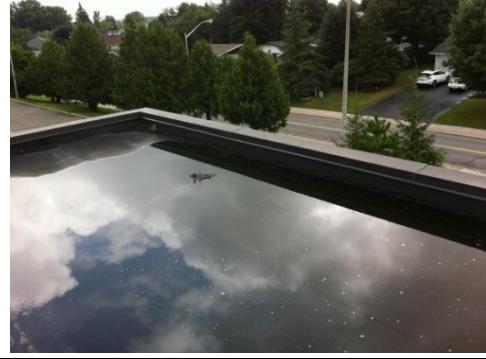
6	Roof drain (main roof)	fair	Due to clogged roof drain strainers, ponding of water on south side of the main building roof	Unclog drain strainers. Regular cleaning and maintenance is highly recommended to prevent ponding.	\$1,500.00

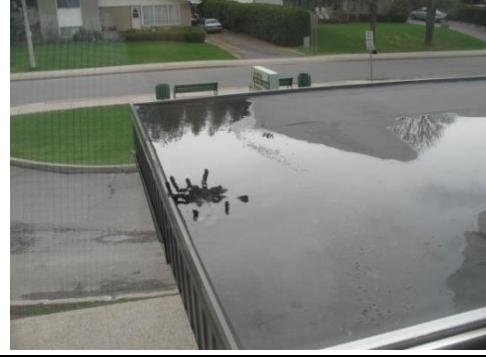
7	Roof drainage issue (vestibule)	fair	No sign of roof leak in the vestibule. However, ponding of water on north side of the vestibule roof due to insufficient roof slope	Remove existing modified Bitumen roofing (about 8 feet from the north edge) and correct roof slope (min. 2%) with fiberboard. Install new bit-mod roof membrane to match existing.	\$8,500.00 (For design and construction)

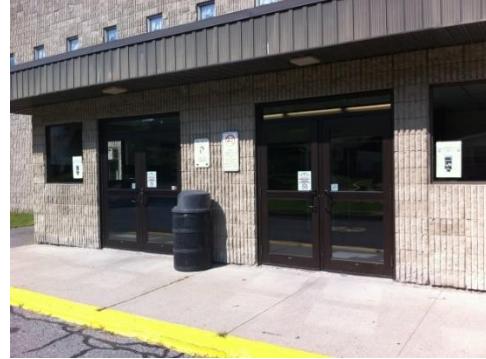
8	Front entrance doors barrier-free accessibility	Poor	No barrier-free access to the building.	Install minimum of one power door operator and push buttons in one door leaf on one of the exterior door and one of the vestibule door (two automatic power door operators in total)	\$4,500.00

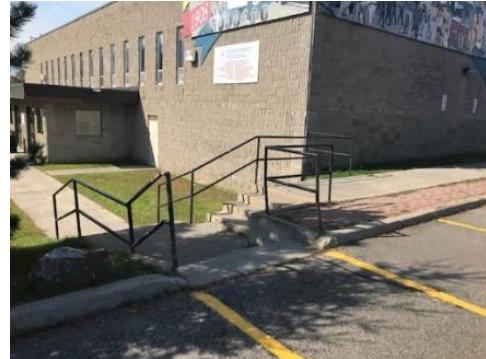
9	Exterior stairs railing and guard	Poor	Existing railing and guard (height, continuity, guards openings) do not meet current O.B.C. section 9.8.	Remove existing railing and guards. Design and install new railing and guards to meet current building code requirement.	\$25,000.00 (For design and construction)

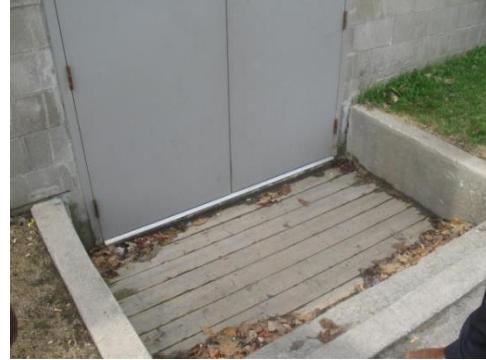
10	Exit doors (x2) clearance (north side)	Poor	Existing depressed pits for the two exit doors require regular maintenance to maintain adequate clearance of the door swing. Riser and tread dimensions do not meet current code requirement. Danger of blockage from ice or snow creates a hazard for emergency egress	Design and modify existing depressed pits to make the exit doors open onto one step with riser not more than 150mm.	\$6,000.00 (For design and construction)

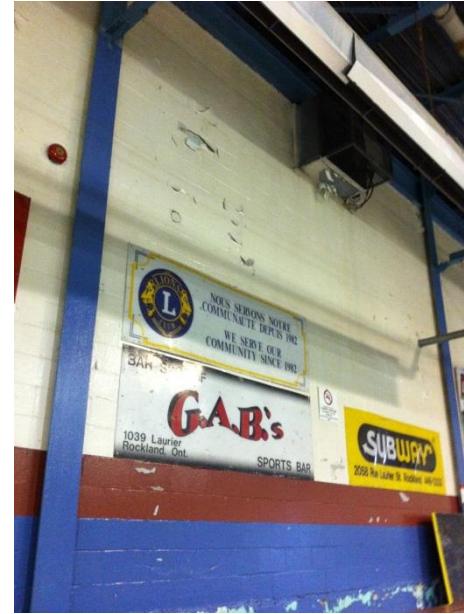
situations.							
11	Exterior Wall Insulation	Poor	<p>There is no insulation installed in the three exterior walls for the multipurpose area. As the concrete blocks wall itself conducts heat to the outside surface, it dramatically increases heating cost for the building.</p> <p>Install rigid insulation, air barrier, exterior sheathing, metal stud wall with batt insulation, vapor barrier, and drywall panel on the inside face of the exterior walls to prevent water penetration and heat loss. Tape and finish drywall surface.</p> <p>Install new weep holes and flashing in existing concrete block walls.</p> <p>Note: It is recommended that the peeling paint to be removed to avoid blockage of new weep holes.</p>	\$480,000.00

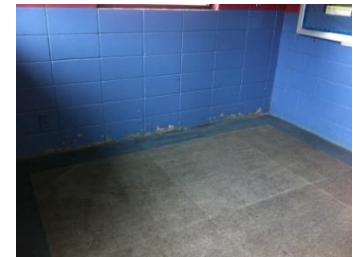
Item	Element	Condition	Comment	Remediation/Action	OPCC	Photograph
1	Interior wall of vestibule at front entrance	Fair	Peeling paint near the base	Prime and apply acrylic latex paint	\$500.00

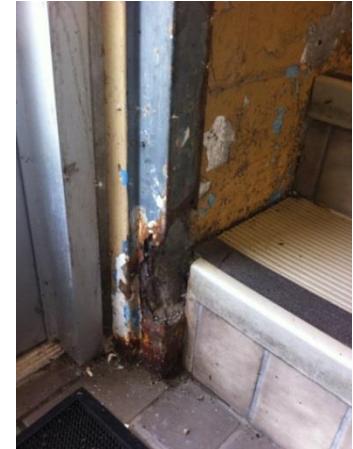
3	Rusted steel at door frames (north facing stairwell)	Poor	Rusting from water and snow	Replace steel angles and repair damaged concrete blocks	\$3,500.00

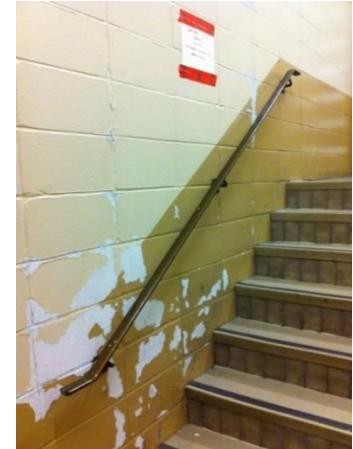
4	Paint finish on stairwell wall (south facing stairwell)	Poor	Paint peeling on all four wall surfaces; direct result of moisture in exterior walls	Remove existing paint; Prime and apply new paint	\$9,500.00

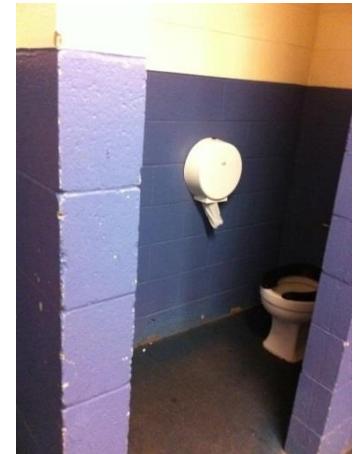
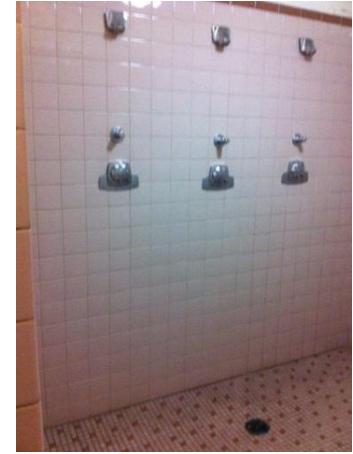
6	Changing room (x4) (men's and women's)	Fair	In fair condition.	Not required.	-

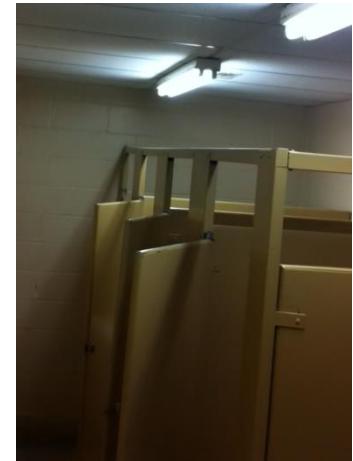
7	First Floor Washrooms (men's and women's)	Fair	Wall paint is peeling off.	Remove existing wall paint and apply new paint.	\$8,500.00

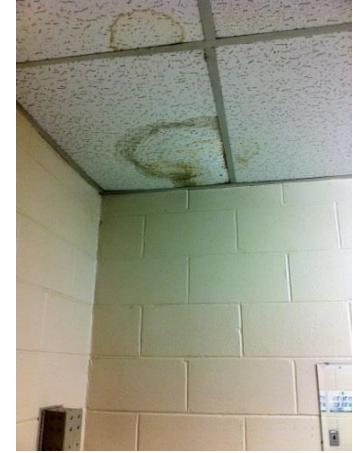
9	Ceiling tiles in community hall, electrical room/storage room, coat check room, and stairwells.	Fair	Water damage of ceiling tile (about 70 tiles).	Replace damaged tiles with new tiles to match existing.	\$3,000.00

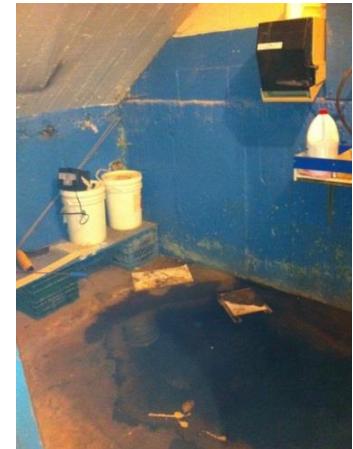
10	Janitor room.	Poor	Very poor floor drainage. Bad odor.	See mechanical section for repairs related to damaged plumbing. Clean, prime, and seal floor with epoxy sealer. Prime and pain walls. Install new shelving, and mop sink.	\$5,000.00

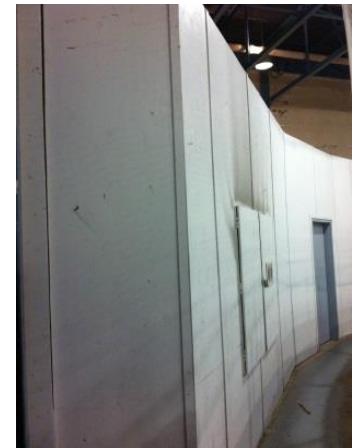
11	Storage Rooms for activity equipment	Poor	Existing storage rooms are constructed of combustible material and without permit.	Remove existing storage rooms.	\$3,800.00 (For demolition and waste disposal)

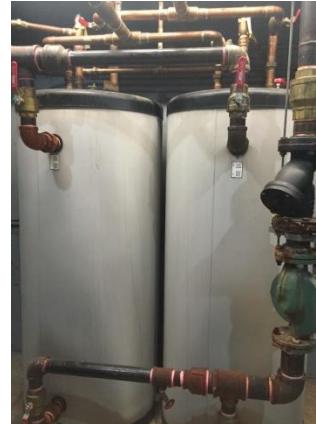
Item	Element	Condition	Comment	Remediation/Action	OPCC	Photograph
1	Two indirect Domestic Hot Water Tanks	Good	Both of the hot water tanks are in good working condition	None required.

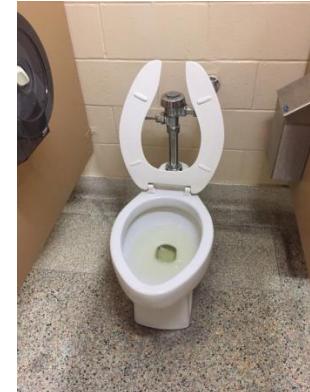
2	All Plumbing Fixtures at ground and 2 nd floor	Fair	The water closets and lavatories are in good working condition.	None required.

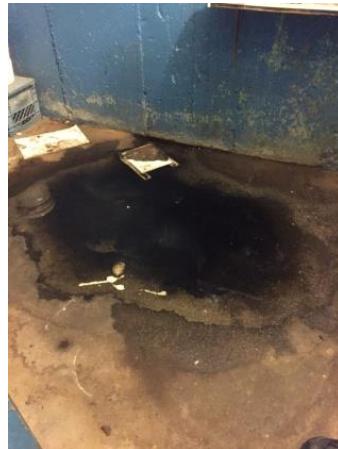
3	Domestic Hot/Cold Water Piping Distributions	Good	There is no double check valve (Backflow preventer) on the main incoming domestic cold water line	Install double check valve on the main incoming domestic water services to meet the OBC Section 7.6.2.6	\$ 8,000.00	-
4	Waste Piping	Poor	Underground sanitary drain is backed up to the ground floor janitor room. Recent camera inspection revealed that the pipe broke at 10" downstream from the floor drain. The physical condition of the entire underground waste piping cannot be determined without camera inspection. Due to the age of the pipes, pipe blockages and failures could occur in the near future.	Broken underground sanitary drain must be repaired. Camera inspection is recommended to investigate and analyze the internal condition of the entire underground sanitary piping. The OPCC for repair/replacement for the entire underground sanitary piping will be determined based on the finding from camera inspection	\$ 16,000.00 (for camera inspection cost and repair the known broken pipe)

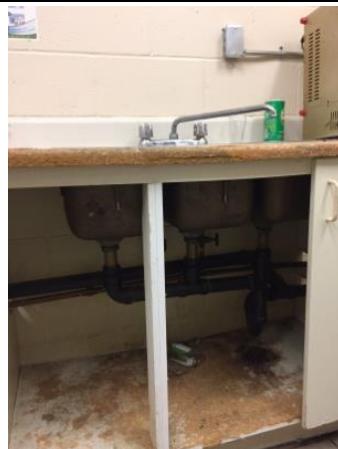
5	Sanitary drains for kitchen sink in the second floor kitchen.	Poor	The kitchen sink sanitary drain does not equipped with grease interceptor which is required by the OBC section 7.4.4.3	Provide grease interceptor for the kitchen sink	\$ 5,000.00

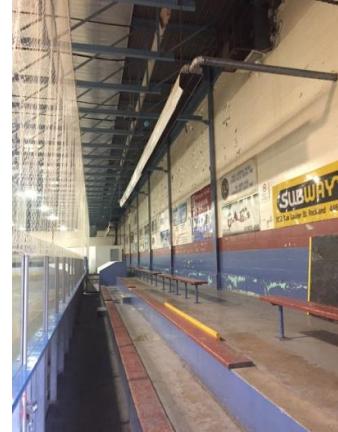
3	Total of 7 (seven) Natural Gas Fired Infrared Heaters in the hockey arena	Poor	Six out of seven units are not functional. One infrared heater will not provide adequate heating for the arena.	Replace all 6 (six) non functional gas fired infrared heaters with new gas fired infrared heaters.	\$ 85,000.00

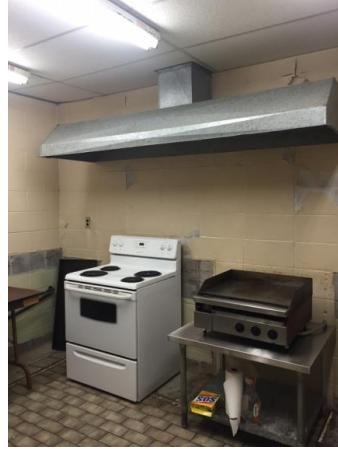
4	Kitchen Hood Ventilation system in the second floor multipurpose room	Poor	The second floor kitchen hood is constructed from galvanized steel which appears not to have an adequate thickness (not less than 1.09mm), listed grease filters or a listed label in accordance with NFPA 96. There is no fire suppression system and make up air in the system. The roof exhaust fan and exhaust ductwork for the kitchen hood is not suitable for this type of application and not in accordance with the NFPA 96 requirements	Replace the kitchen hood, exhaust ductwork and exhaust fan with new which will be in compliance with the NFPA 96. Provide make-up air unit on the roof with gas fired heater to preheat the outside air. Provide manual pull station, portable fire extinguisher type K and fire suppression system complete, connected to the fire alarm control panel as separate alarm zone.	\$ 42,000.00

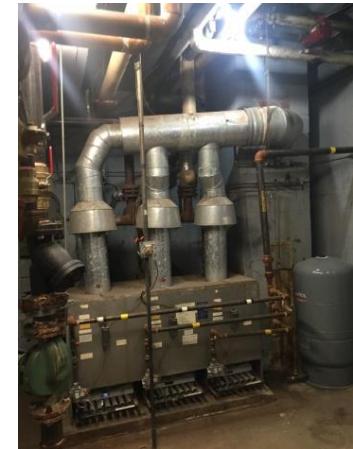
6	Three gas fired heating boilers	Fair	The boilers are in good working conditions.	None required.	-

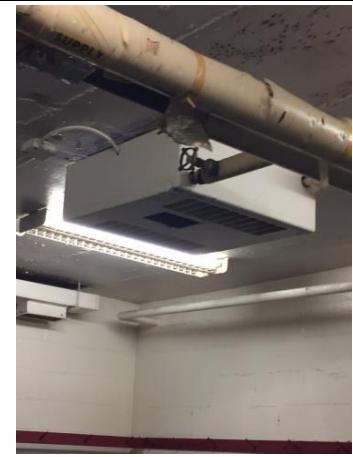
7	Hot Water Heating piping	Fair	There are missing pipe insulation in some pipe sections. Pipe corrosion noted in the mechanical room which should be monitor closely.	Provide pipe insulation on the sections of pipes which have missing insulation.	\$ 8,000.00

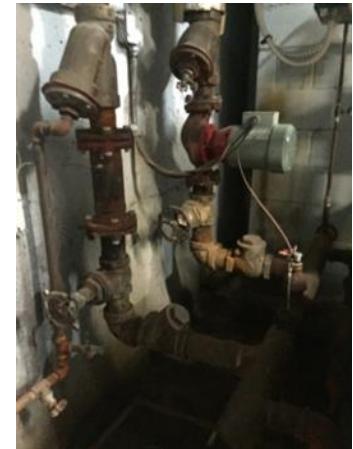
8	Circulation Pumps and Sump Pumps	Good	The circulation pumps and sump pumps are in good working condition	Not Required.	-

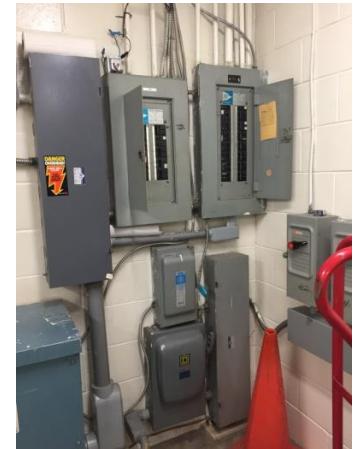
2	Electrical Power Distribution and Panels, Disconnect switches, Dry core step-down transformers and panels.	Good	The electrical power distribution components are in good working conditions. Implementing Arch Flash study and safety sign labeling for safeguarding persons or property from hazards associated with electrical installations for shock and arch flash protection is recommended. These requirements indicated on the Ontario Electrical Safety Code 2015, Section 2-306, and CSA Z462-2018, NFPA 70E and ANSI Z535.4.	Perform arc flash study for the electrical distribution system and provide safety signs and labels on all electrical panels and disconnect switches to warn persons of potential electric shock and arc flash hazard present, so employees can be aware of the associated hazards of the equipment and assign appropriate PPE	\$ 15,000.00 (Study)

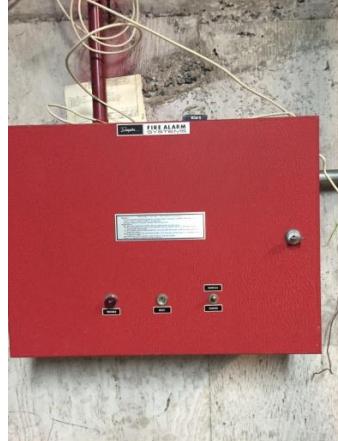
Item	Element	Condition	Comment	Remediation/Action	OPCC	Photograph
1	Fire Alarm Control Panel (FACP)	Fair	The fire alarm control panel is outdated but it is in good working condition.	None required

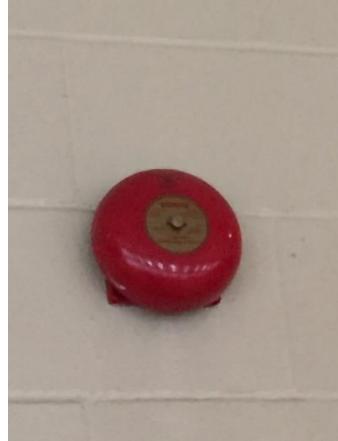
2	Fire alarm devices, i.e.: bell, manual pull station and heat detector	Fair	The fire alarm devices are in good working condition	None Required

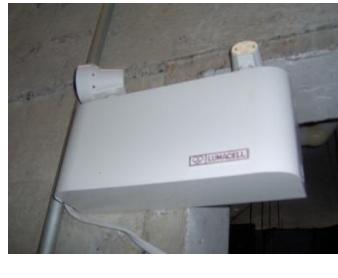
3	Emergency Lighting	Good	The emergency battery pack units with emergency light heads are in good working conditions. Based on the number of emergency lights currently available on site, there are some areas within the building expected to have emergency lighting level below 10 lx which is not in accordance with the Ontario Building Code, Section	New emergency lights should be added to maintain a minimum average lighting level of 10 lx throughout the floors areas, including in the ice rink area.	\$ 20,000.00

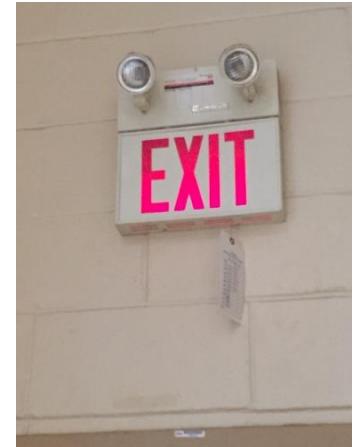
3.2.7.3(1)			
4	Exit Sign	Good	The illuminated exit signs are in good working conditions. The exit signs do not conform to the CSA C860 regulations and to provide energy efficient exit lighting.	Replace existing exit sign with new LED exits sign with "Green Running Man"	\$ 6,000.00
